# GeoRadar Division

## *GPR High Frequency Investigation*

### *Concrete test site*

*Highways Department - Bangkok – Thailand (1/4)*

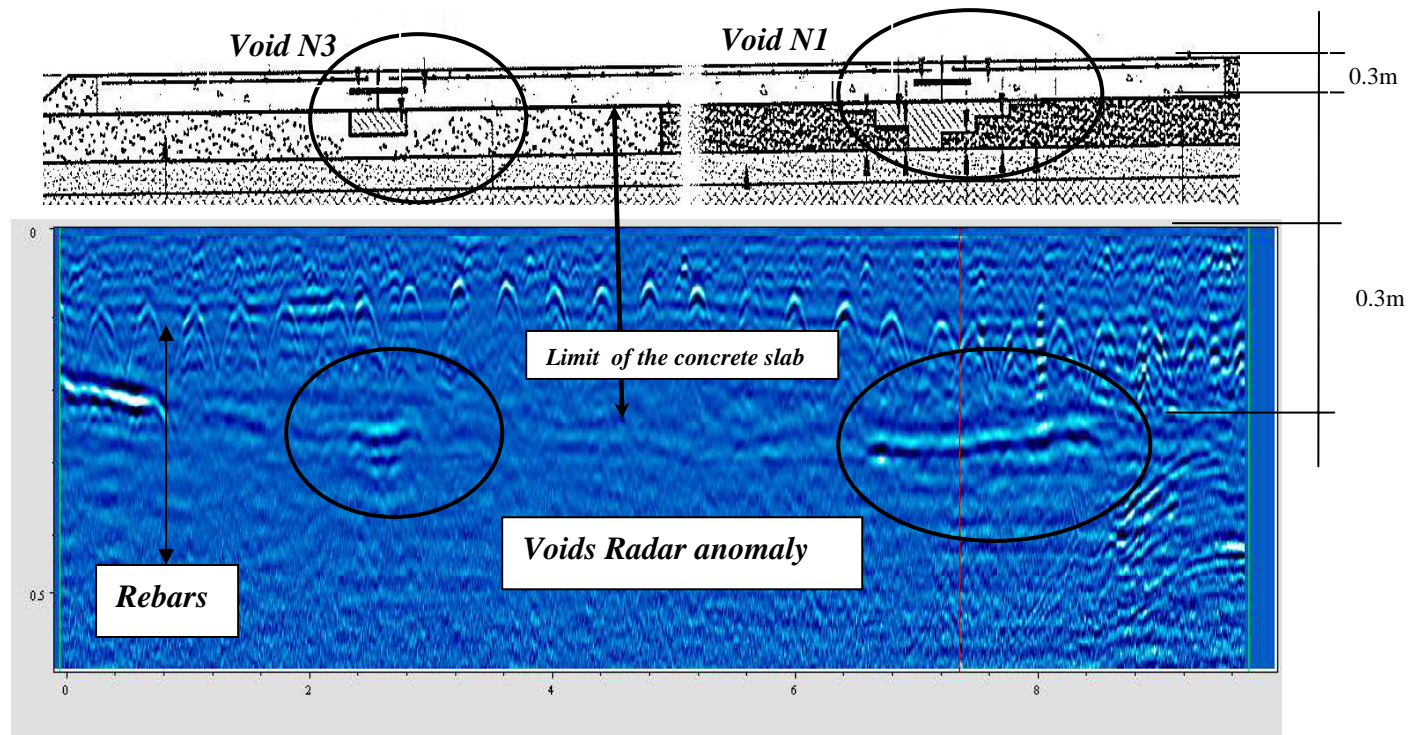
2Ghz radar section compared with the original sketch; the depth of the radar map has been stretched in order to view the void anomaly

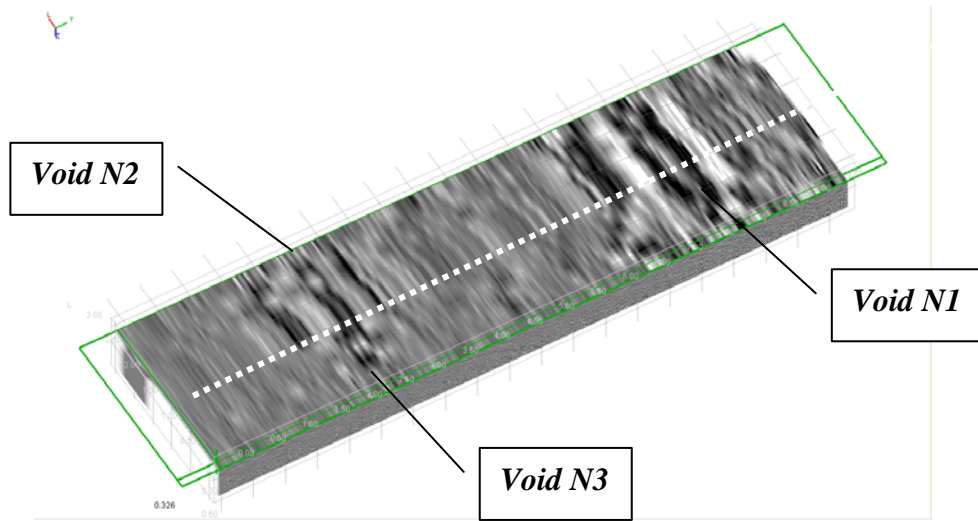
3D view of the test site cut at 32cm from the surface it shows three anomalies created by the voids

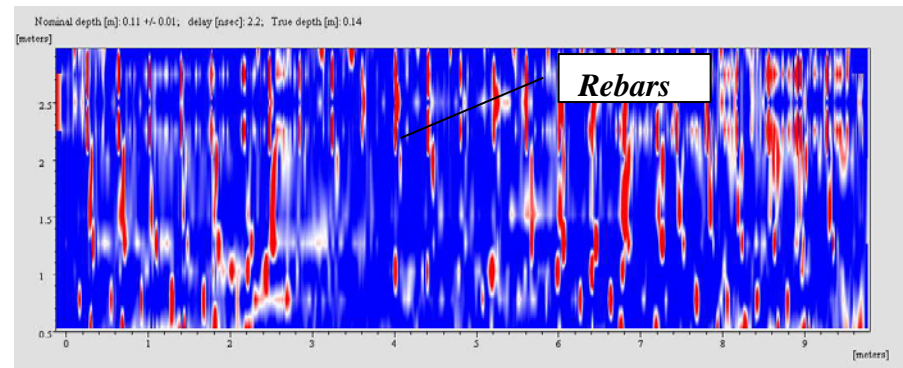
Time slice, show the anomalies created by still bars located in the concrete slab

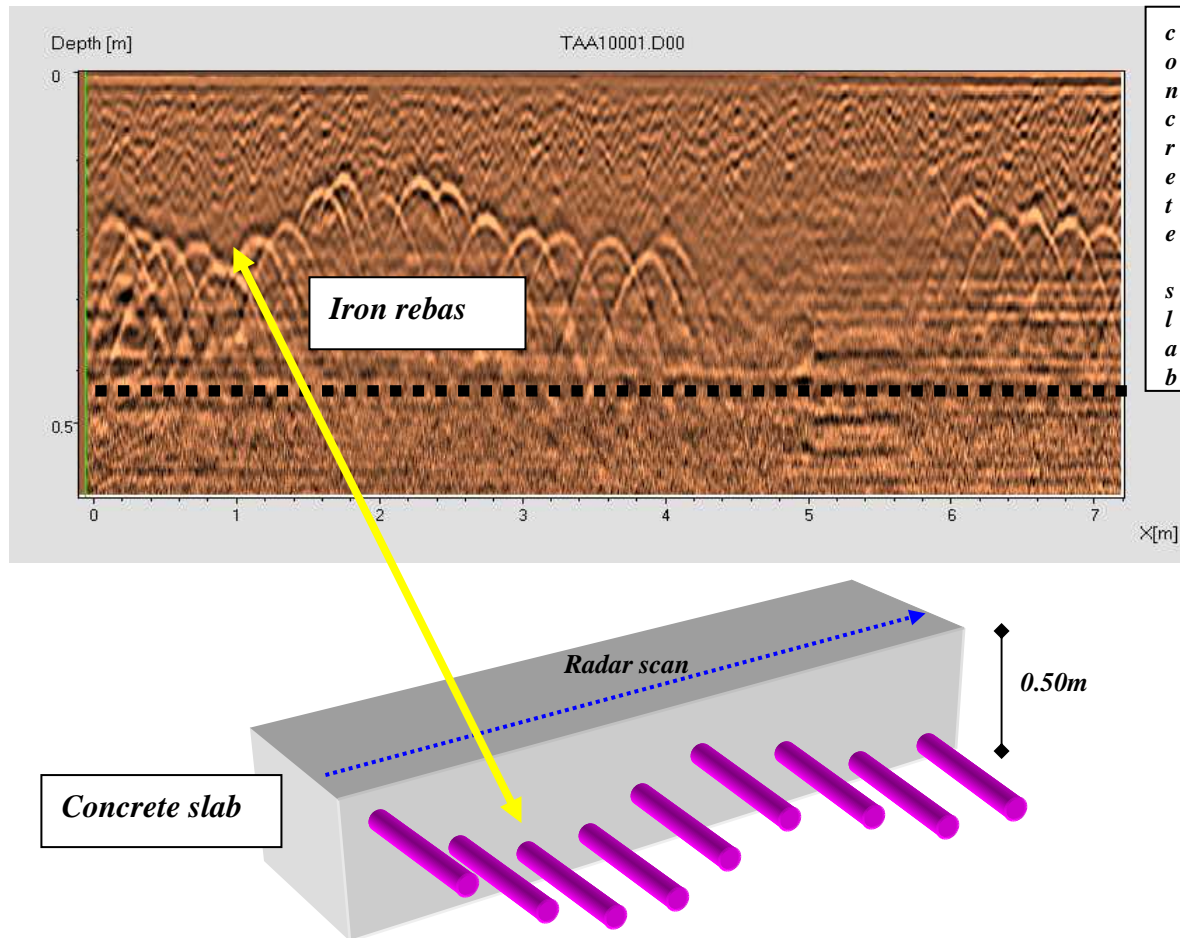
**2GHz radar section acquired along the border between two concrete slab;  
the map shows clearly the depth difference among each single rebar**

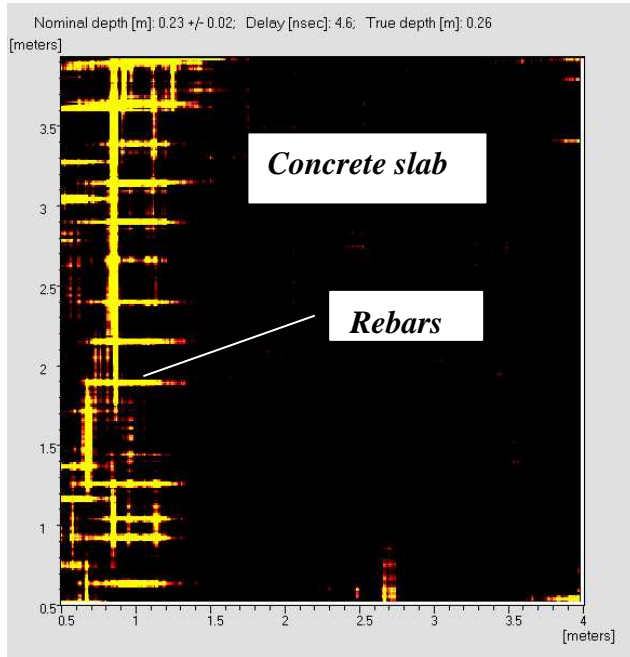
Time slice, show the anomalies created by still bars located in the concrete slab

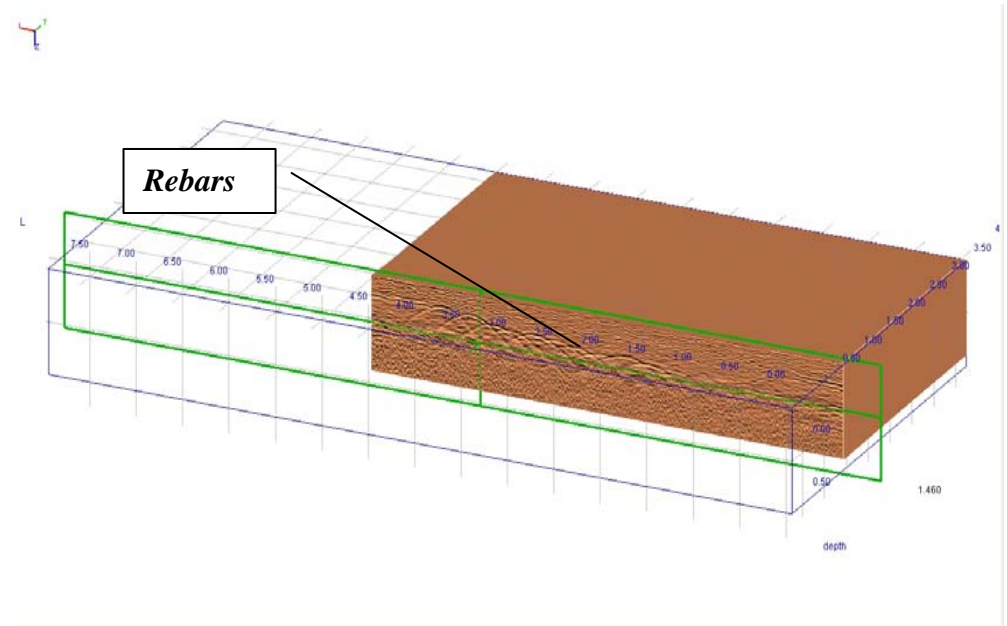
3D shows the anomalies originated by the rebar
