# GeoRadar Division

## *GPR High Frequency Investigation*

### *Concrete test site*

*Highways Department - Bangkok – Thailand (1/4)*

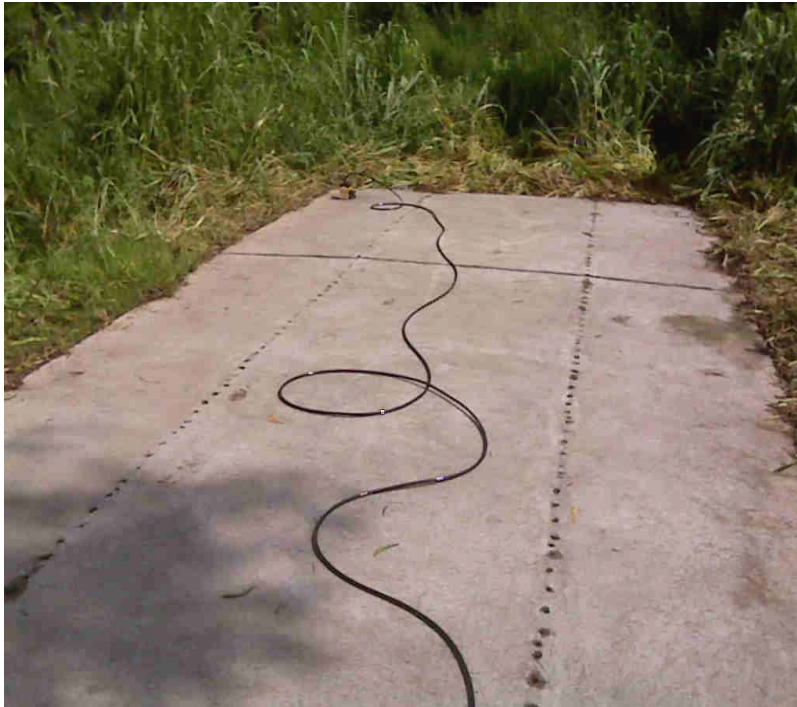
Tests site in the *Asian Institute of Technology*

GPR investigation on the test site of *Highways Department of Bangkok* to evaluate:

- The presence and the position of the void under the concrete slab
- The presence and the position of rebars in the concrete slab

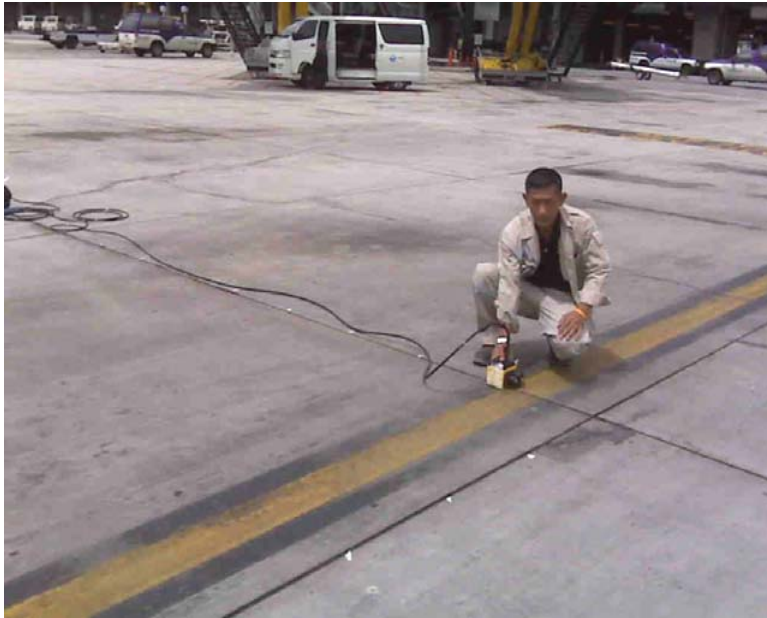
Tests site in the International Airport of Bangkok

GPR investigation on the test area of *Airports of Thailand Public Company* evaluate:

- The presence and the position of rebars in the concrete slab
